ULTRASONIC INSPECTION OF CERAMICS CONTAINING SMALL FLAWS.(U)

MAR 77 T DERKACS, I M MATAY, W D BRENTNALL

TRW-ER-7867-F

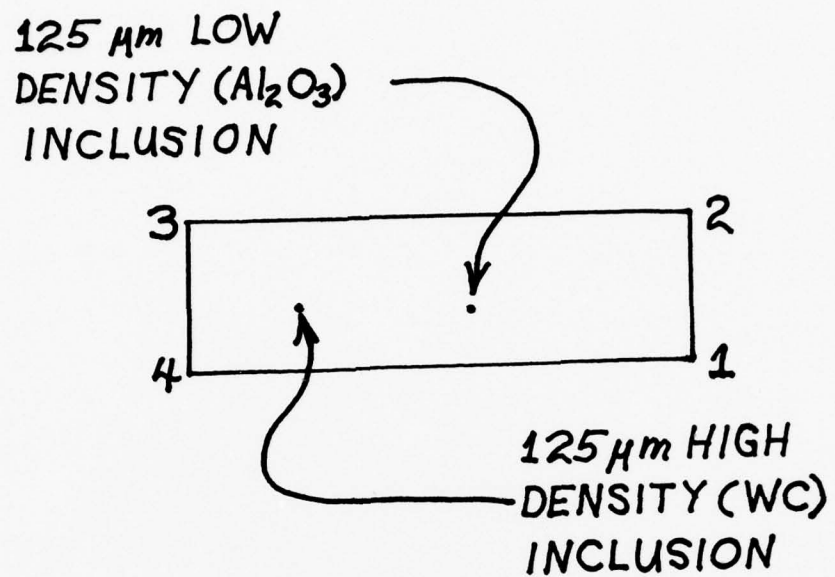
Figure 1. Layout of Ceralloy 147A, Hot Pressed Silicon Nitride Internal Defect Standard (IDS).

Two ultrasonic reference standards were used in this program. The first is a section of Ceralloy 147A billet 7.30 x 2.17 x 0.64 cm in size containing one seeded 125 μm low density (Al_2O_3) defect and one seeded 125 μm high density (WC) defect 2.5 cm apart (see Figure 1). This standard was left over from the previous program in which similar seeded defects were examined by scanning electron microscope (SEM) fractography (Ref. 1). This reference standard is called the internal defect standard (IDS), and appears in each of the C-scans of the program specimens.

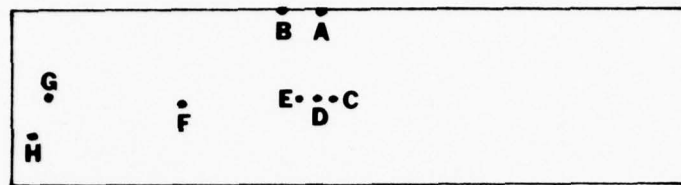
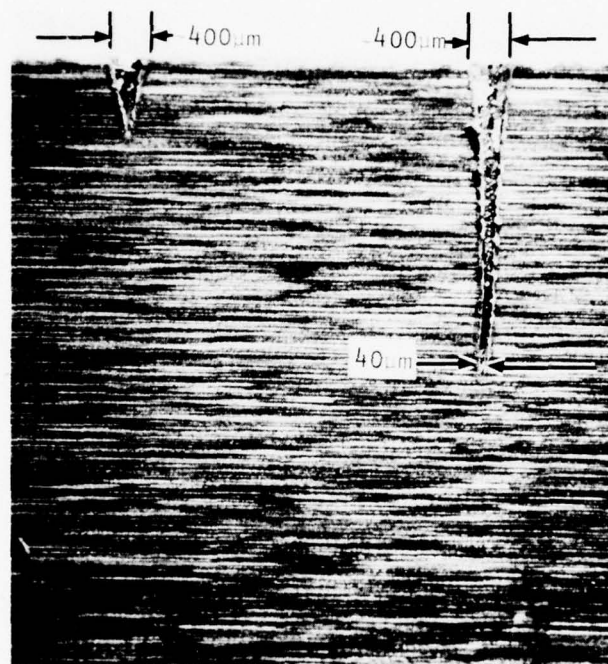
Figure 2. Ceralloy 147A, Hot Pressed Silicon Nitride, Standard (LDS) Containing Laser Drilled Holes.

The second reference standard is another section of Ceralloy 147A from the same billet as the IDS. The standard is 4.90 x 1.33 x 0.64 cm in size and contains eight laser drilled holes (see Figure 2) of various depths which are not known with any accuracy. Two of the holes were drilled at the edge to give an estimate of the typical cross-section. Figure 2 shows a) the layout of the holes and b) an 18X micrograph of the cross-section of the edge holes. The longer of the two edge holes is about 400 μm in diameter at the opening, but only 40 μm near the tip. Over the course of its 2600 μm depth, it increases in diameter by a factor of ten. The shorter hole is just as large at the surface and slightly smaller at the tip. The other six holes are about the same size at the opening, except for F which is only 125 μm . Holes F and H go all the way through the part. This reference standard is called the laser drilled standard (LDS) and appears in most of the shear wave C-scan recordings.

a. Layout of Laser Drilled Holes in Standard As Seen During Inspection (i.e., Holes Down).

b. Photograph of Edge Holes Showing Typical Hole Profiles (18X).

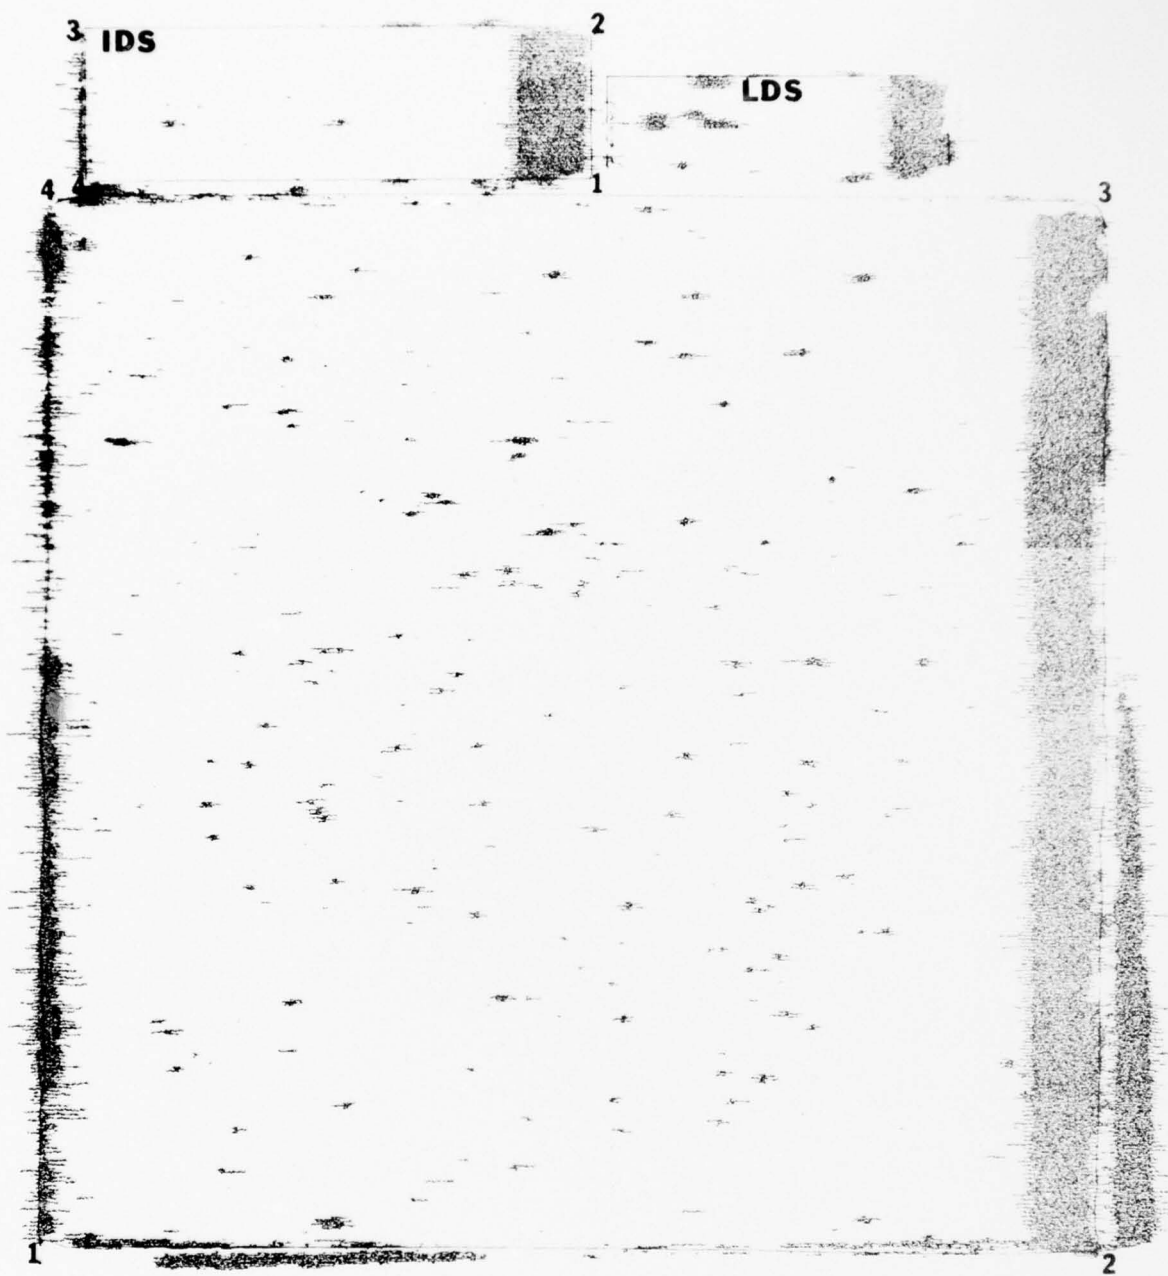
Figure 14. C-scan Recording of 45 MHz, 11° Shear Wave Inspection of Ceralloy 147A, After Machining Using Longer Defect Gate.

Figure 7 shows the IDS, LDS and billet of Ceralloy 147A inspected using the single gate width shear wave technique. Figure 14 shows the same scan made with the double gate width technique. In Figure 14 the deadband along the right hand edge of each part is twice as large as in Figure 7, the holes in the LDS are seen, the indications from the seeded defects in the IDS are larger and there are many more indications in the Ceralloy 147A. It was concluded from these scans that the double gate width technique offers improved sensitivity and reduces the probability of failing to detect a large defect (such as the holes in the LDS) due to unfavorable orientation.

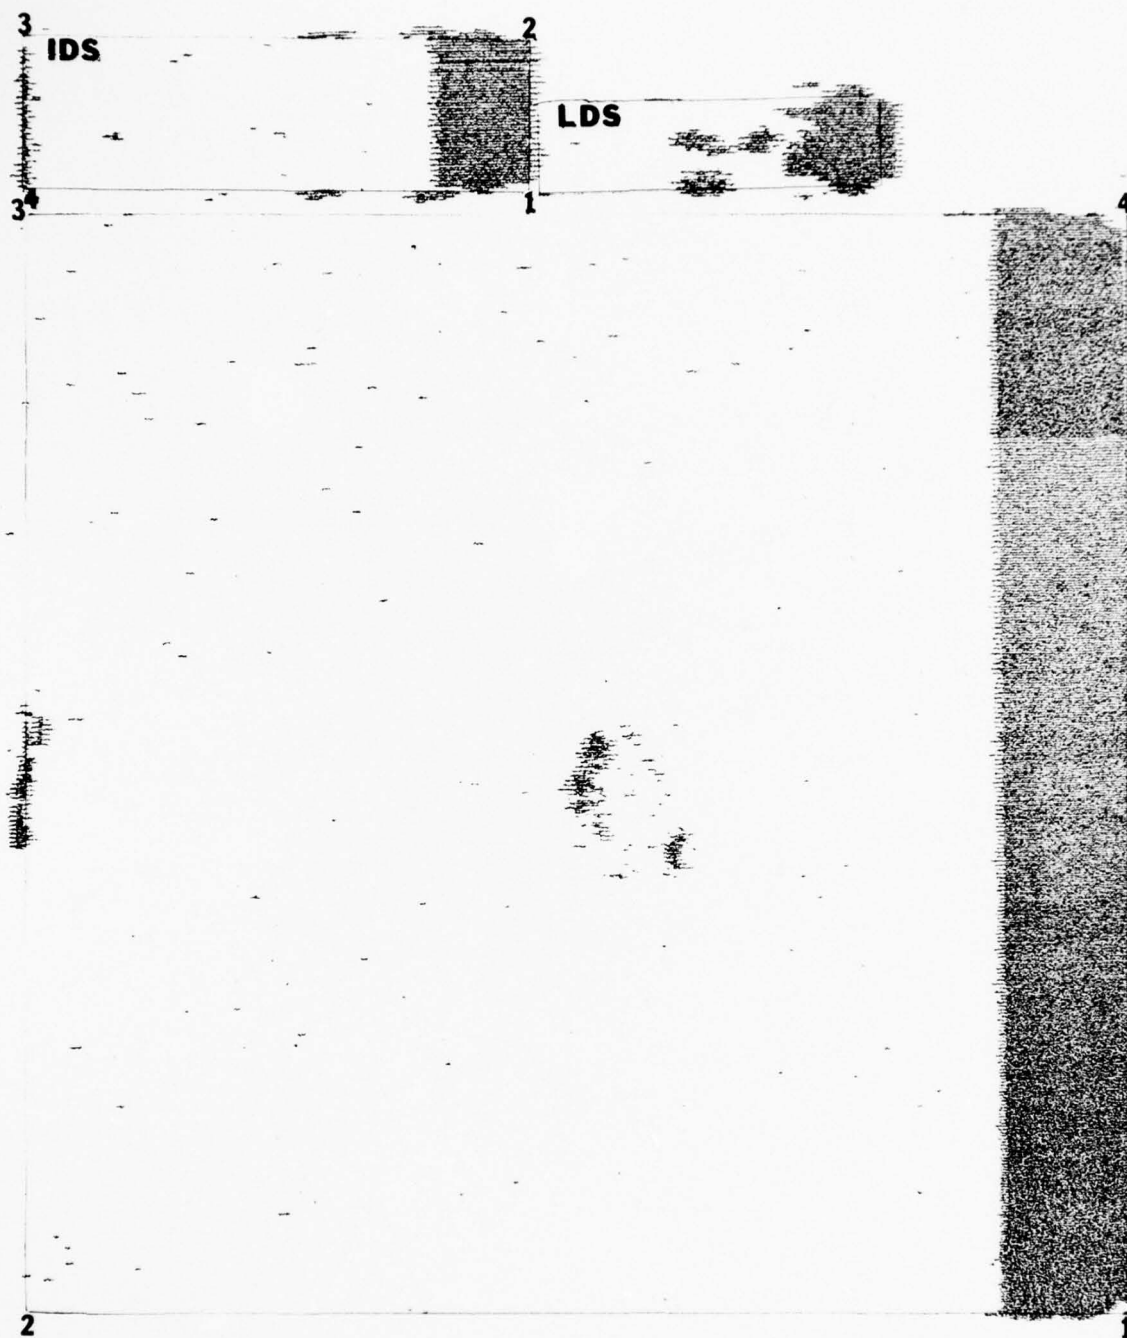
Figure 15. C-scan Recording of 45 MHz, 11° Shear Wave Inspection of NC-203A After Machining with Surface Porosity Up.

The Ceralloy 146A, which was inspected in the previous program using longitudinal waves and found to have only a few small defects, was not found to have any additional defects by shear wave inspection. The billets of NC-203A were also found to be relatively free of defects, except for the area of visible surface porosity near the center. This area was detected both by shear wave inspection from either side (Figures 13 and 15) and by longitudinal wave inspection from the same side (Figure 16). The A-scan display observed during the inspection shown in Figure 16 revealed that this defective area is not confined to the surface but extends somewhat into the material.

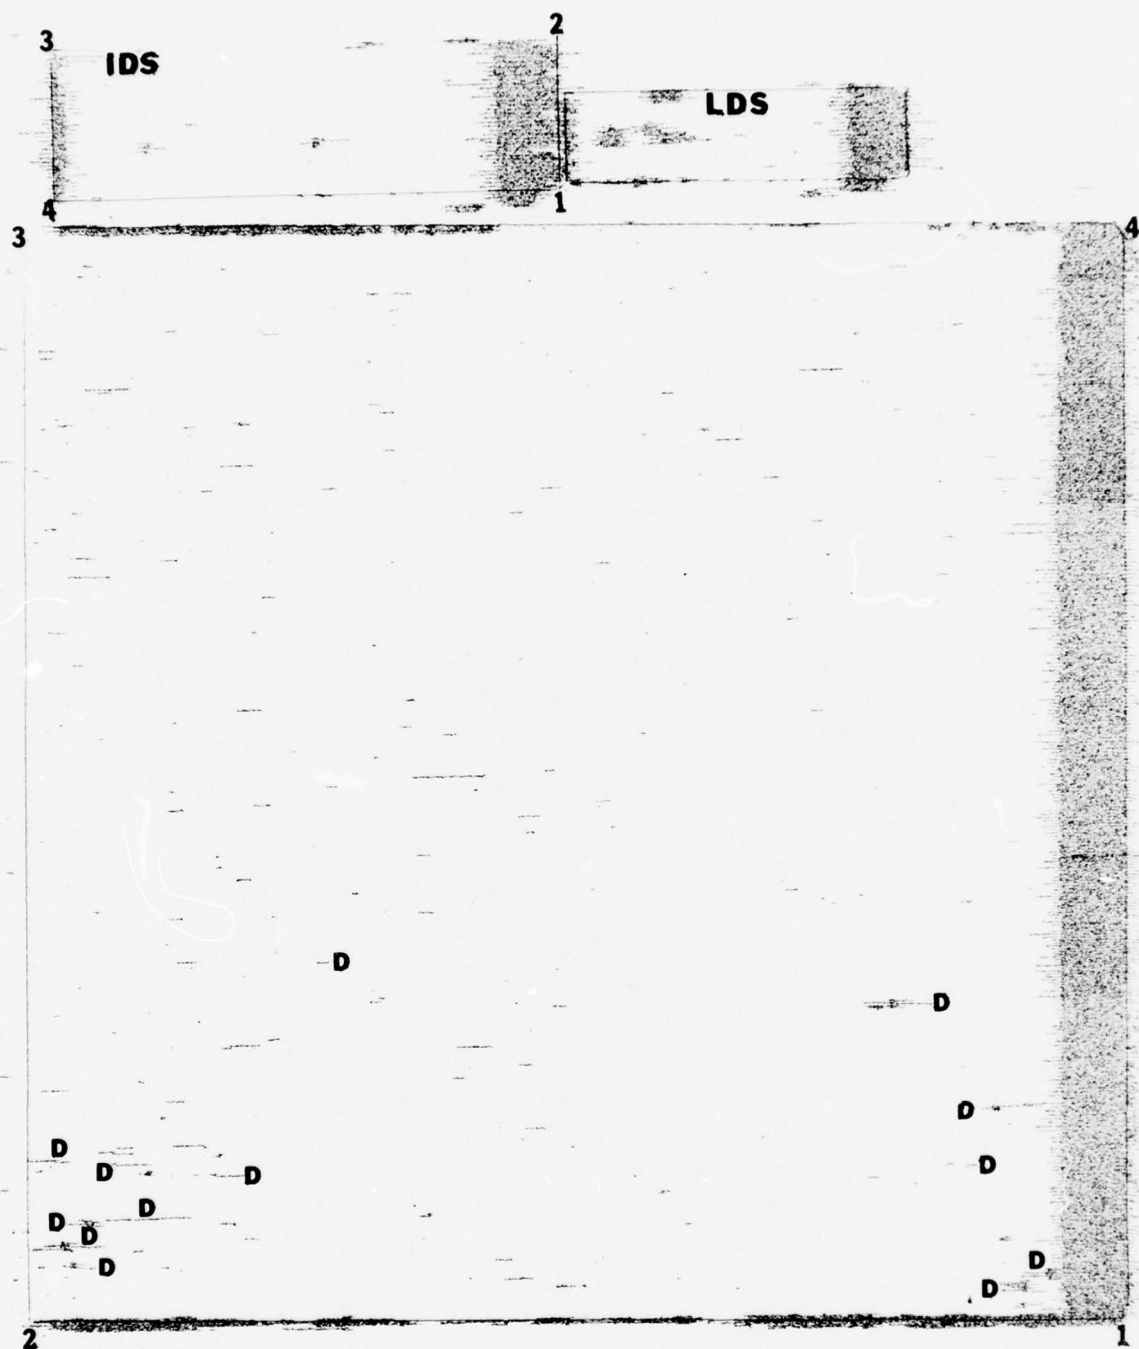
Figure 17. C-scan Recording of 45 MHz, 11° Shear Wave Inspection of NC-132.

The billet of NC-132 was also relatively free of defects. In addition to one small defect detected by longitudinal wave inspection (labelled D in Figure 9), a number of mostly small defects were detected by the shear wave technique (Figures 17 and 18). These two figures show C-scan recordings for shear wave inspections made at two orientations 90° apart. The indications labelled D appear in both figures. Subsequent measurements of defect depths revealed most of these indications to be the result of residual surface pits that were too deep to remove by surface machining. In contrast, the billet of Ceralloy 147A was found to have a large number of defects scattered throughout the part (Figure 14). Because of the large number of scans and the large number of defects in each scan, it is difficult to present an overall recording of the inspection results on this billet which would clearly distinguish the circumstances under which each defect is detected. However, Figures 19 and 20 summarize the

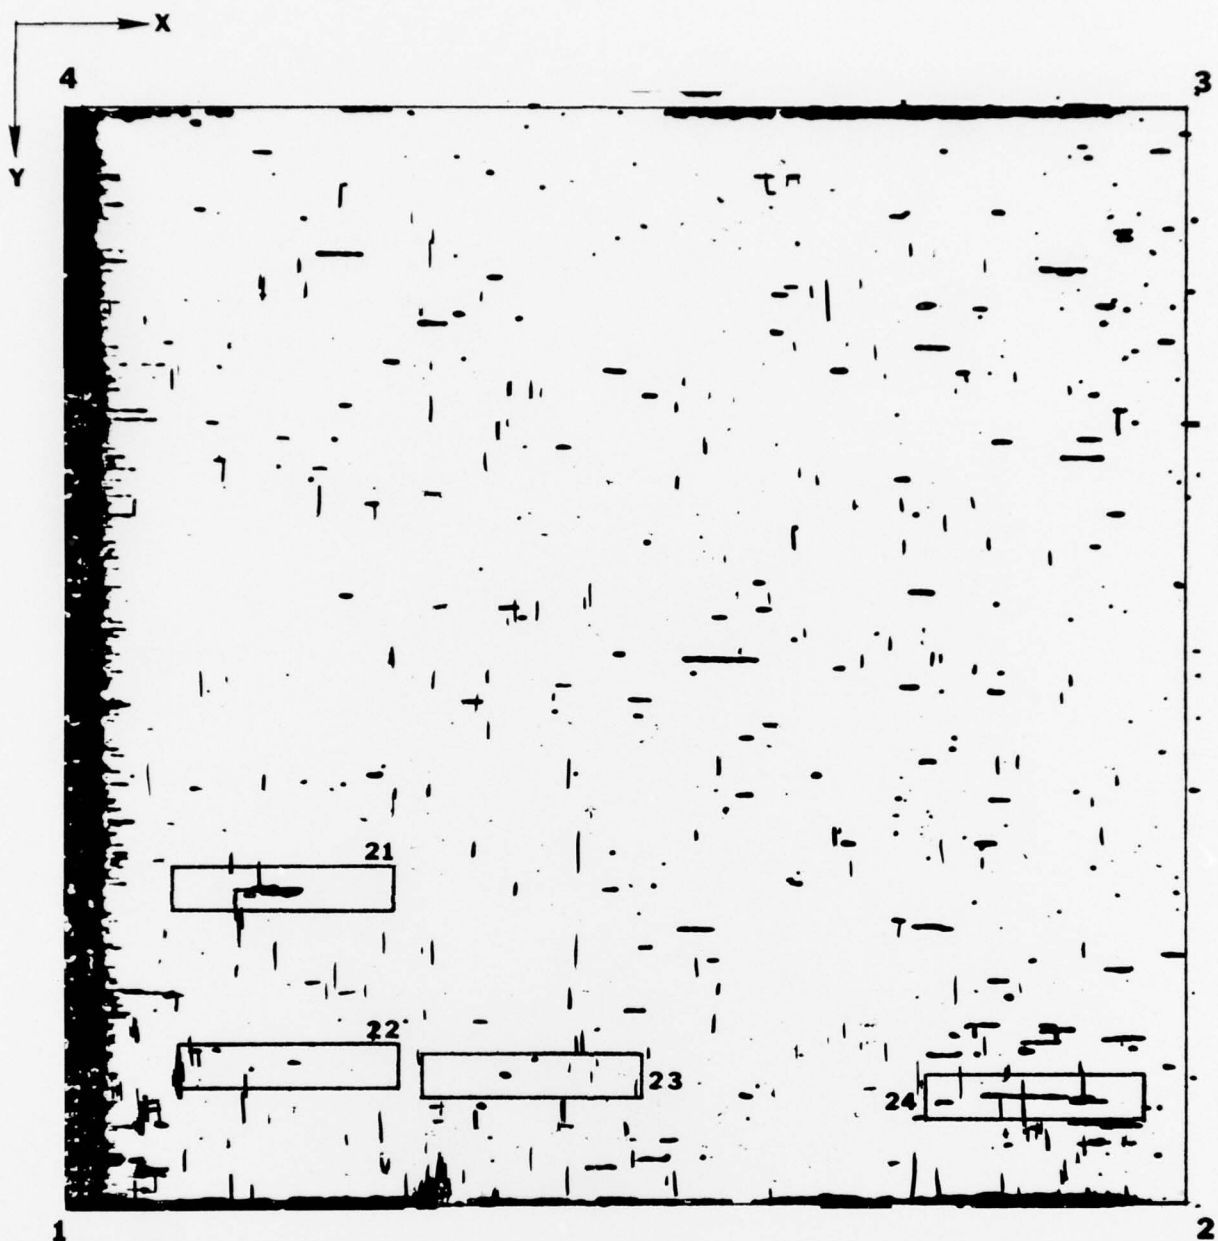
Figure 35. Specimen Locations in Billet of NC-132.

Four of the six defects whose locations were measured were selected for flexural strength specimens. Three of these four defects were found to be surface pits and the fourth was identified by depth measurement as being close to the surface. The specimens were prepared in the same manner as the specimens of Ceralloy 147A, except that no material was machined from the tensile surface in order to avoid removing the defects. Figure 35 shows a layout of the specimens on the C-scan.

specimen 23 shattered, so that the fracture origin was lost and specimen 24 broke off center. In the case of specimen 24 the surface defect could be observed on one piece of the broken specimen well away from the fracture origin. There were not enough specimens of this material to draw any statistically significant conclusions, however, the general pattern of strengths versus types of failures was similar to the results for Ceralloy 147A.
